CITY OF FITCHBURG

Report on Blight Determination Ridgewood District

August 23, 2005

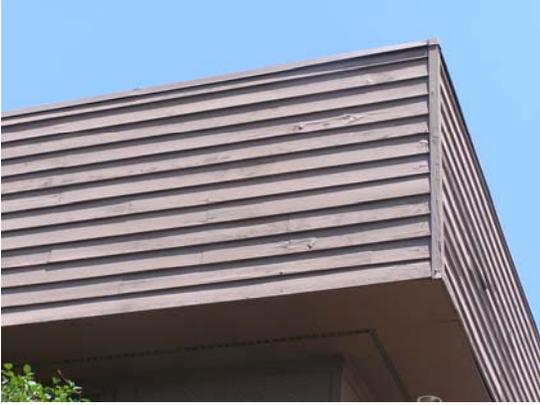
3070 Fish Hatchery Road
Deteriorated Clap Board Siding
July 9, 2005

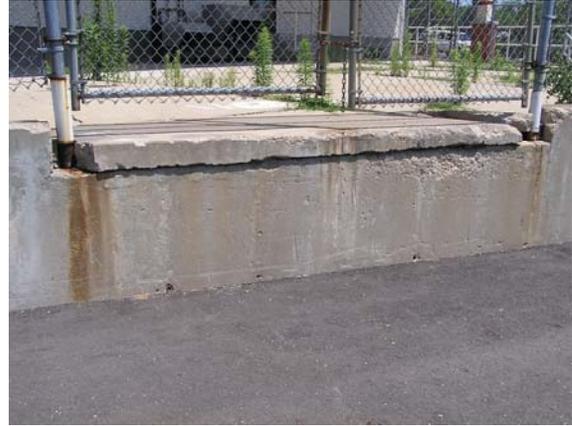
Fitchburg Ridge Shopping Center
Deteriorated Loading Dock
July 9, 2005

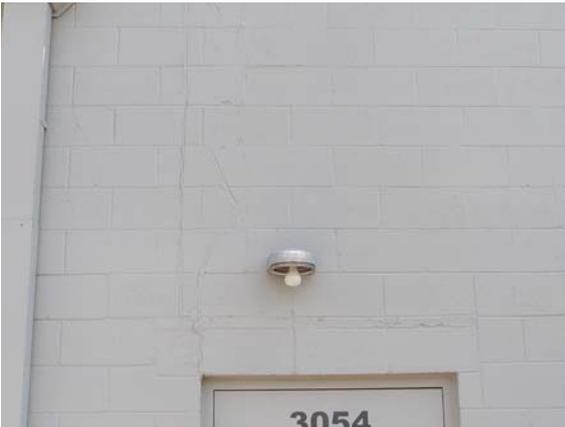
Fitchburg Ridge Shopping Center
Cracked Wall
July 9, 2005

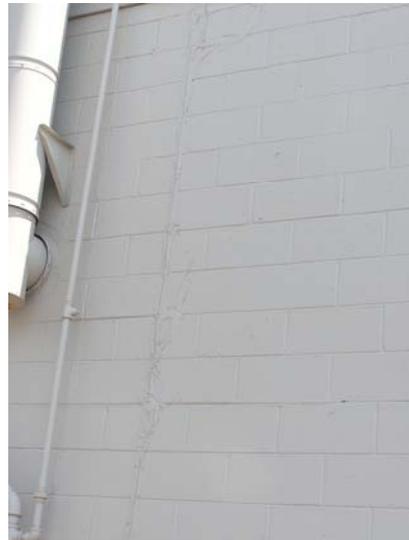
Fitchburg Ridge Shopping Center
Cracked Wall
July 9, 2005

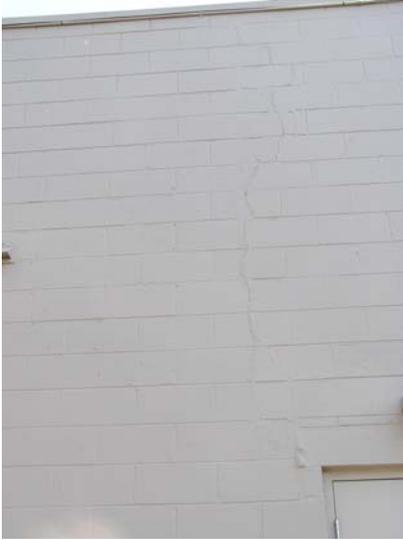
Fitchburg Ridge Shopping Center
Cracked Wall
July 9, 2005

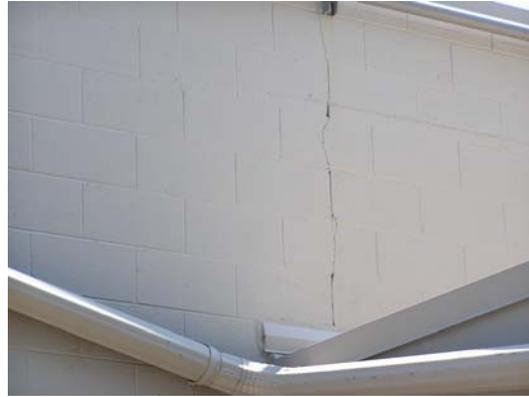
Fitchburg Ridge Shopping Center
Cracked Wall
July 9, 2005

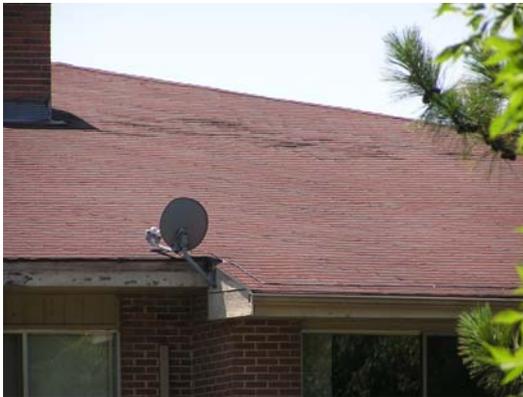
2101 Post Road
Deteriorated Shingles
July 9, 2005

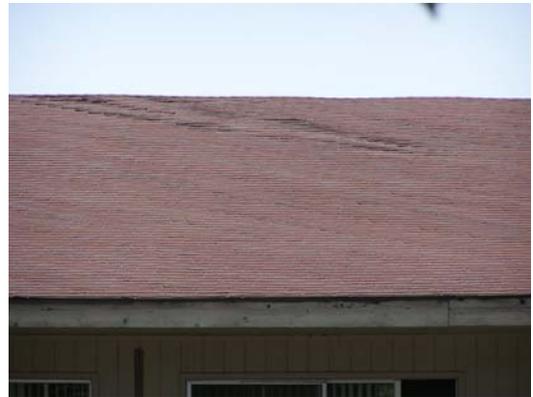
2101 Post Road
Deteriorated Shingles
July 9, 2005

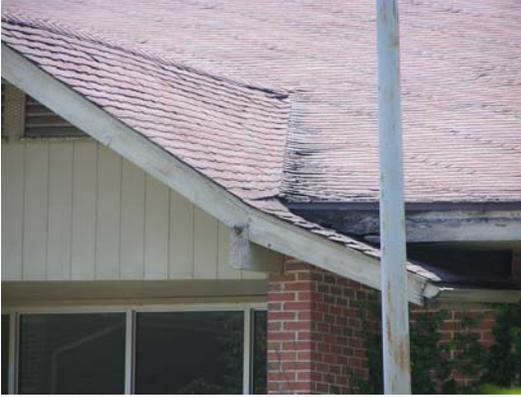
2101 Post Road
Deteriorated Shingles
July 9, 2005

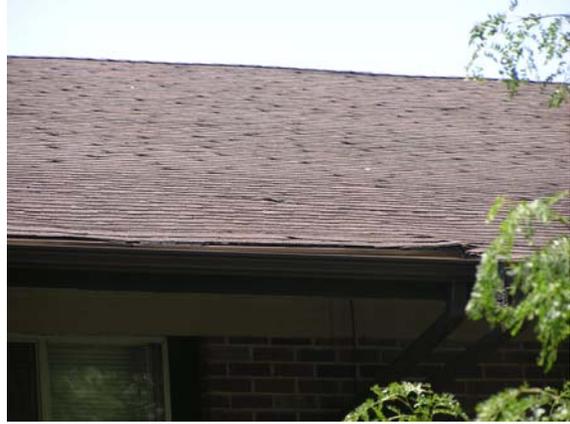
2201 Post Road
Deteriorated Shingles
July 9, 2005

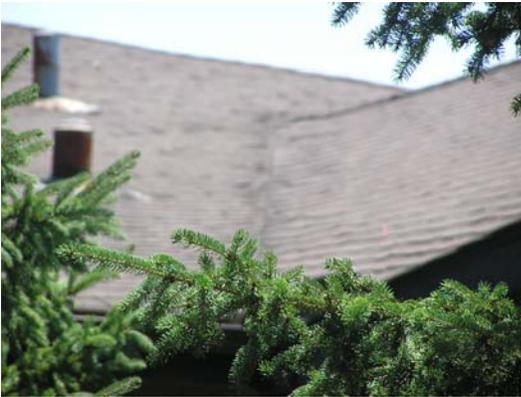
2201 Post Road
Deteriorated Shingles
July 9, 2005

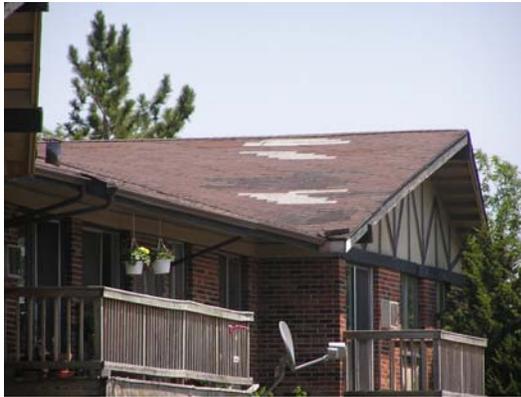
2201 Post Road
Deteriorated Shingles
July 9, 2005

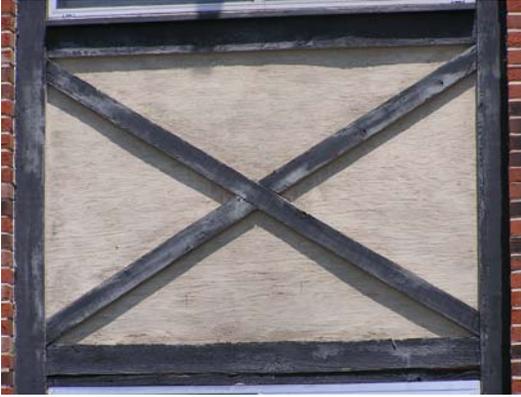
2201 Post Road
Deteriorated Wood Siding
July 9, 2005

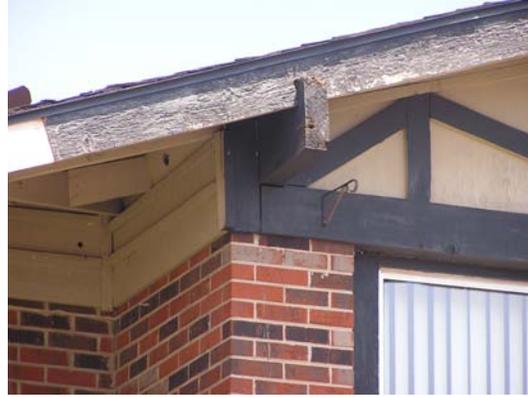
2201 Post Road
Deteriorated Fascia
July 9, 2005

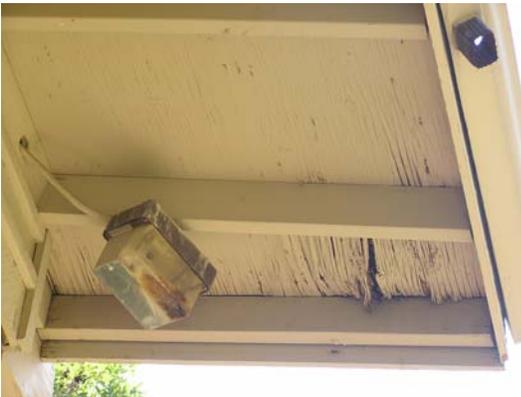
2301 Post Road
Deteriorated Soffit
July 9, 2005

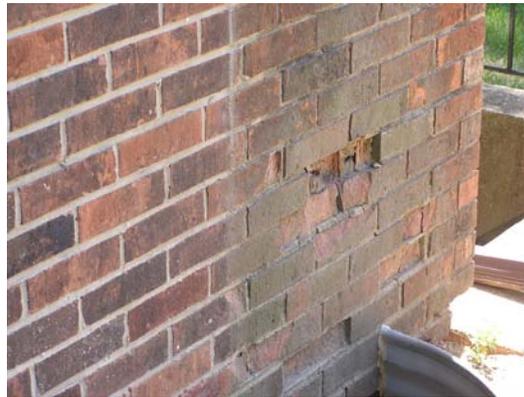
2301 Post Road
Water Damaged Bricks
Broken Bricks
July 9, 2005

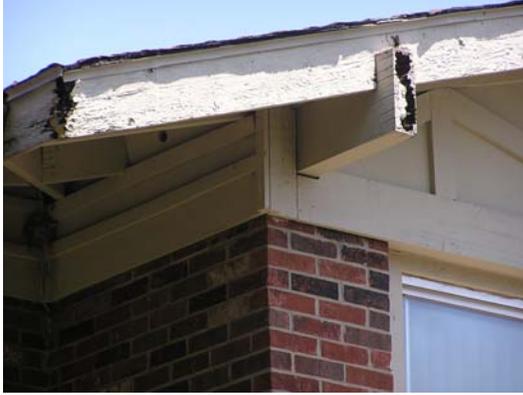
2301 Post Road
Rotted Fascia
July 9, 2005

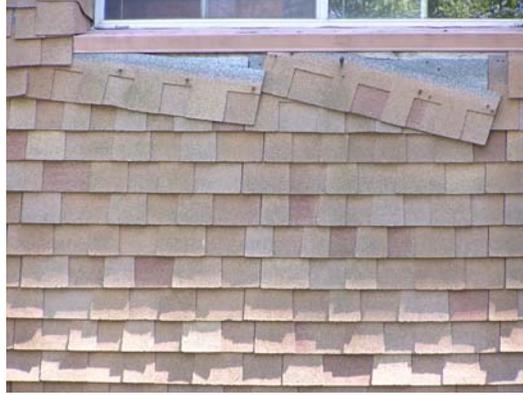
2601 Post Road
Loose Wall Shingles
July 9, 2005

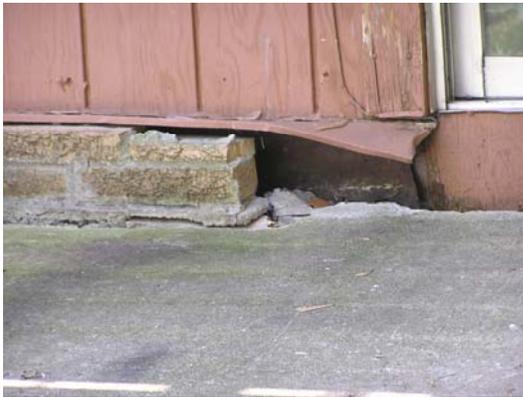
2601 Post Road
Brick Wall Broken
Deteriorated Wood Siding
July 9, 2005

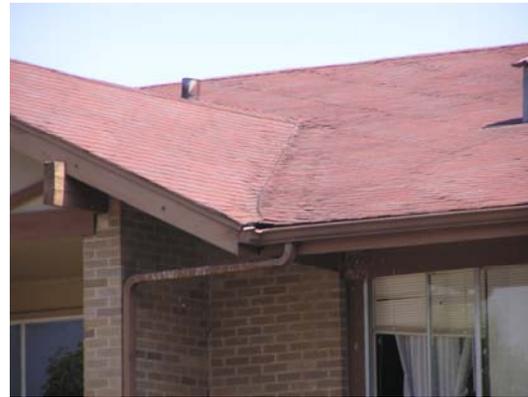
2501 Post Road
Shingles Deteriorated in Gutter
July 9, 2005

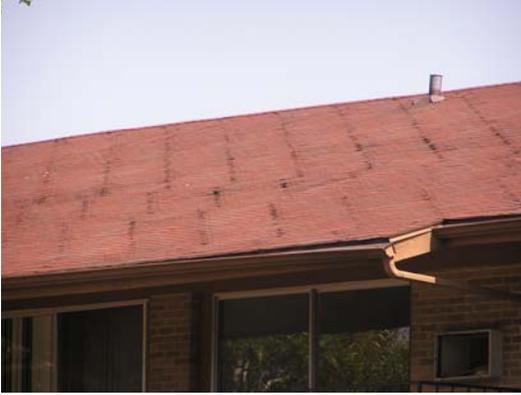
2501 Post Road
Deteriorated Shingles
July 9, 2005

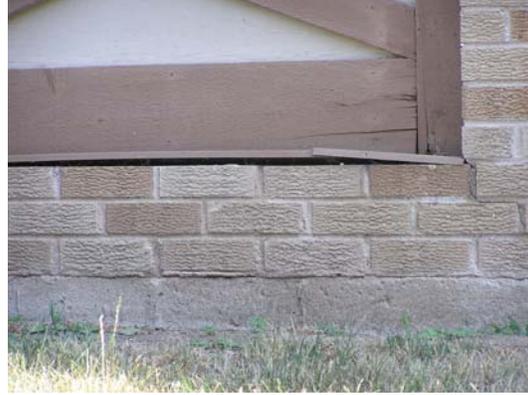
2501 Post Road
Cracked Wall
Deteriorated Trim
Wrapped Trim
July 9, 2005

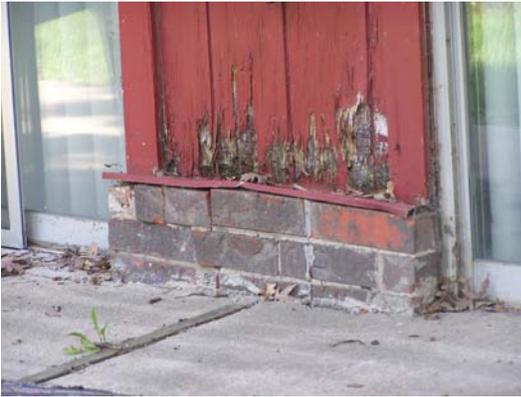
3314 Leopold Way
Rotted Siding, Broken Brick
July 9, 2005

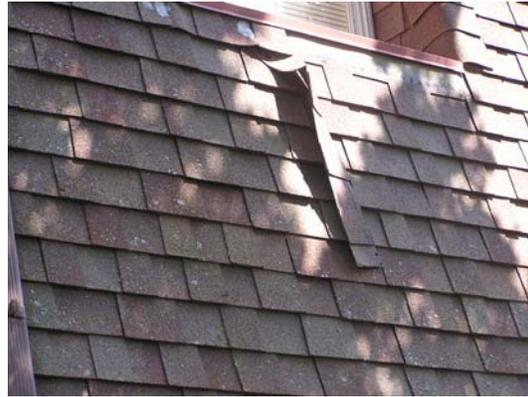
3314 Leopold Way
Loose Shingle Siding
July 9, 2005

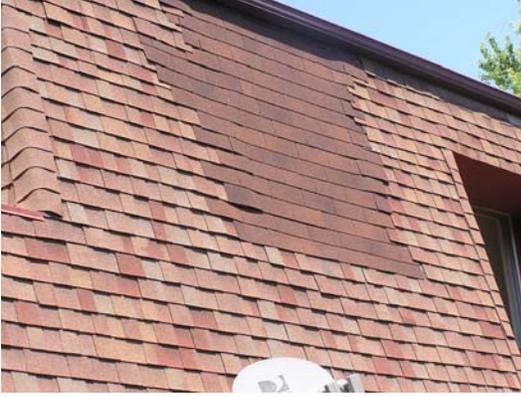
3314 Leopold Way
Patched Siding
July 9, 2005

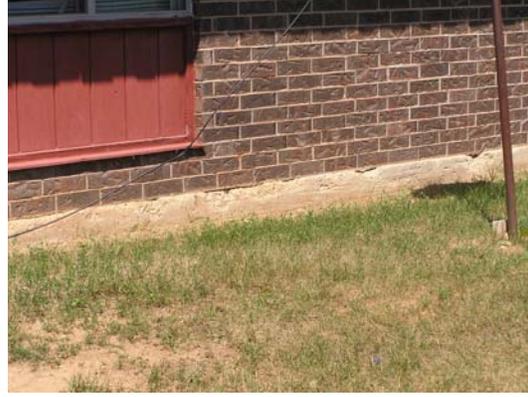
3314 Leopold Way
Deteriorated Concrete Foundation
July 9, 2005

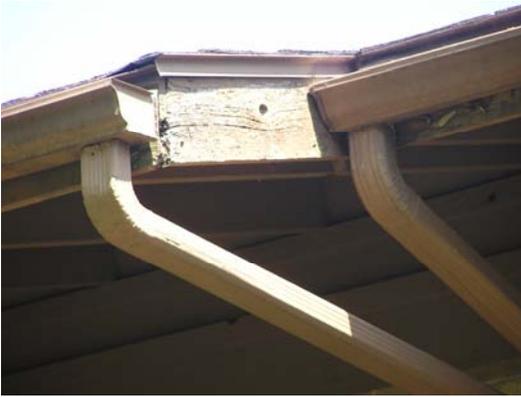
3302 Leopold Way
Deteriorated Fascia
July 9, 2005

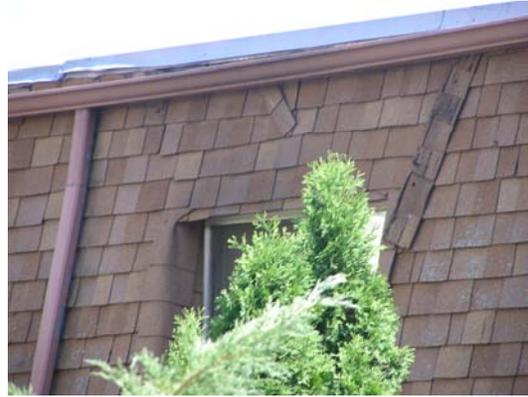
3313 Leopold Way
Loose Siding and Fascia
July 9, 2005

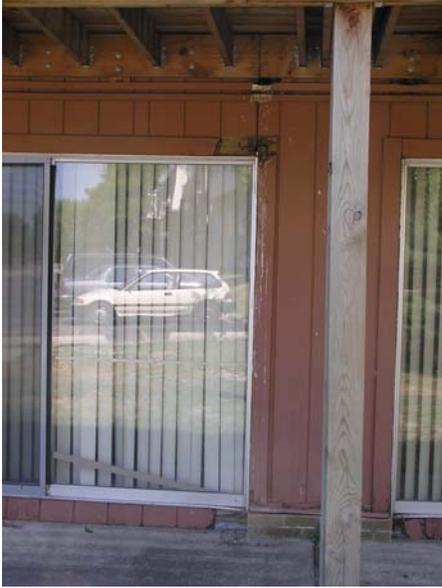
3313 Leopold Way
Deteriorated Door Frames
July 9, 2005

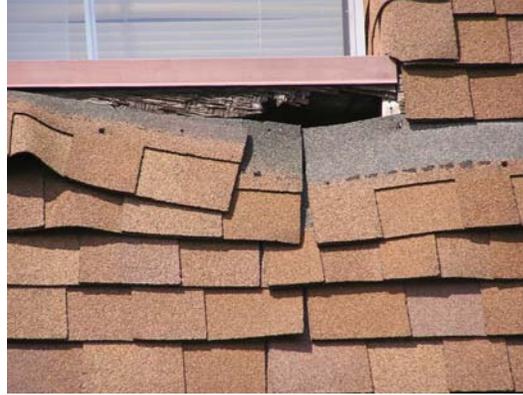
3313 Leopold Way
Loose and Missing Shingles
Exposing Rotted Frame
July 9, 2005

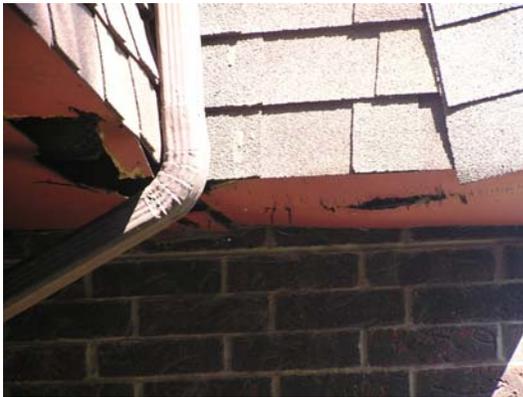
3309 Leopold Way
Rotted Soffit
July 9, 2005

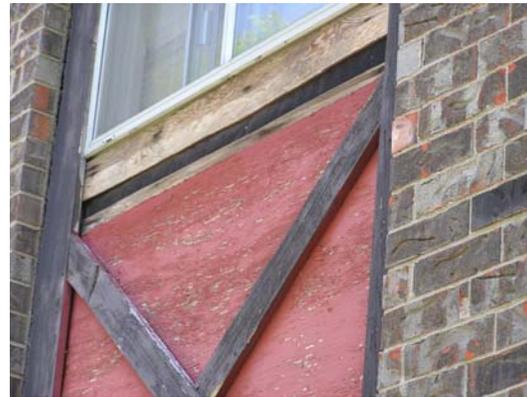
2325 Traceway Drive
Deteriorated Panel
Board Missing
July 10, 2005

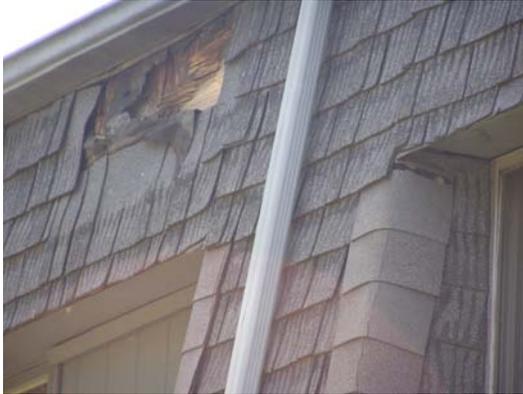
2122 Traceway Drive
Siding Missing Exposing
Deteriorated Wood
July 10, 2005

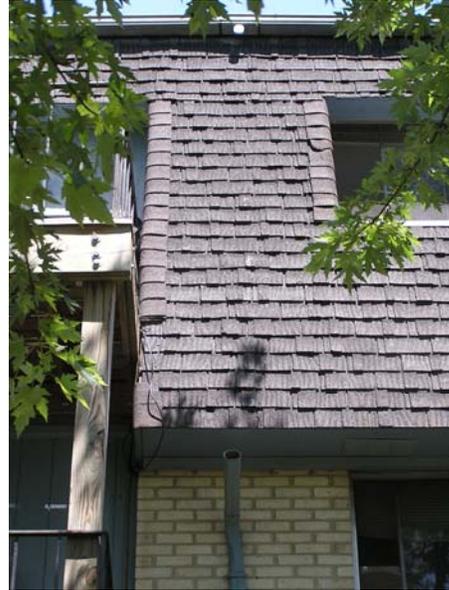
2101 Traceway Drive
Downspout Missing
July 10, 2005

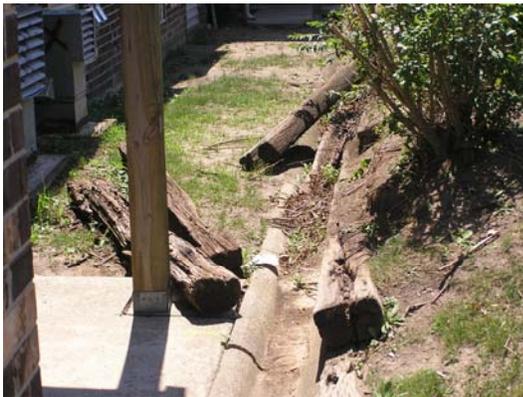
2110 High Ridge Trail
Deteriorated Retaining Wall
July 10, 2005

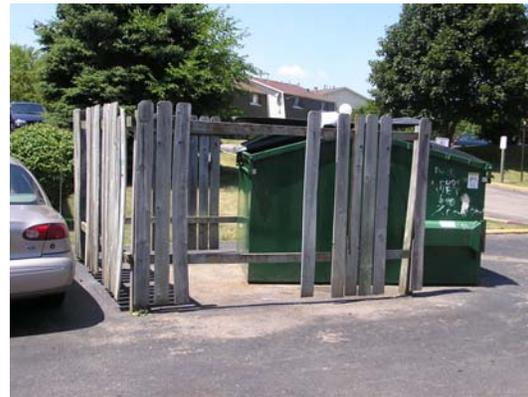
2102 High Ridge Trail
Inadequate Outdoor Storage
July 10, 2005

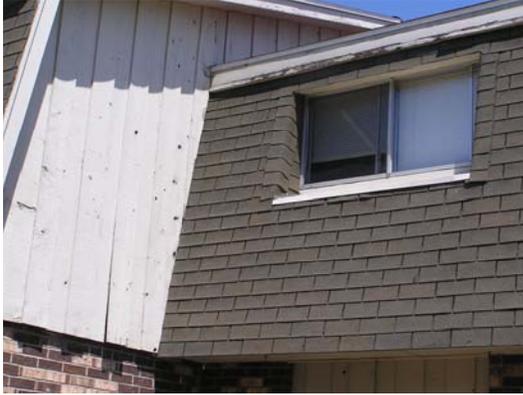
2210 High Ridge Trail
Gutter Missing Exposing
Deteriorated Fascia
Siding Loose
July 10, 2005

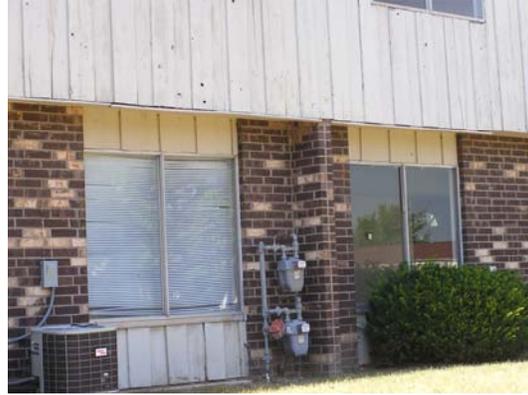
2230 High Ridge Trail
Sagging Trim
Deteriorated and Loose Siding Boards
July 10, 2005

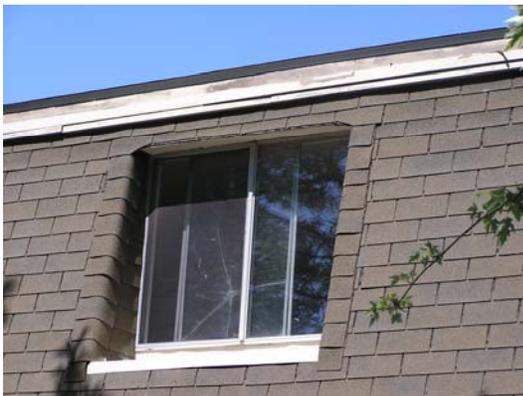
2146 High Ridge Trail
Broken Glass
Missing Gutter
Deteriorated Fascia
July 10, 2005

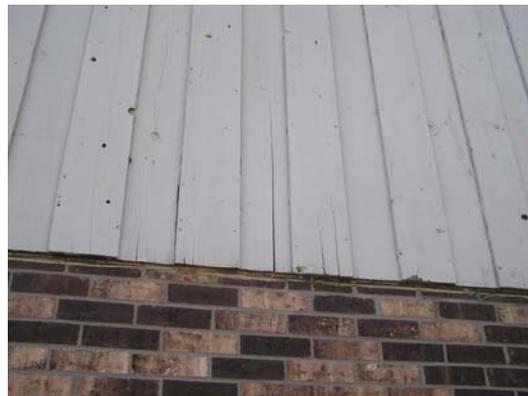
2246 High Ridge Trail
Split Wood Siding
Deteriorated Wood
July 10, 2005

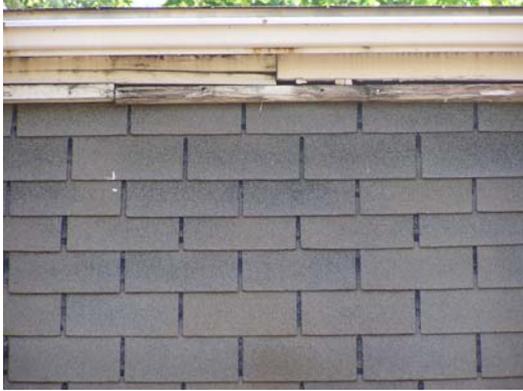
2282 High Ridge Trail
Rotted Fascia
July 10, 2005

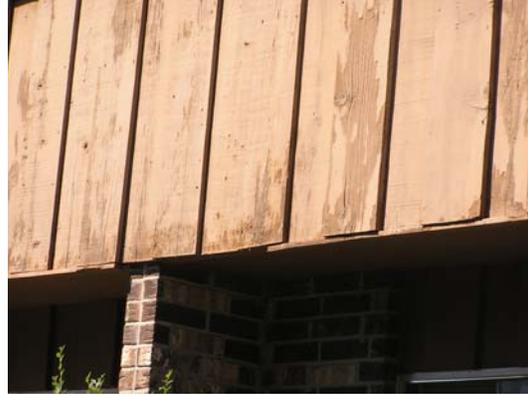
2316 High Ridge Trail
Missing Trim
Split Siding Boards
Deteriorated Boards
July 10, 2005

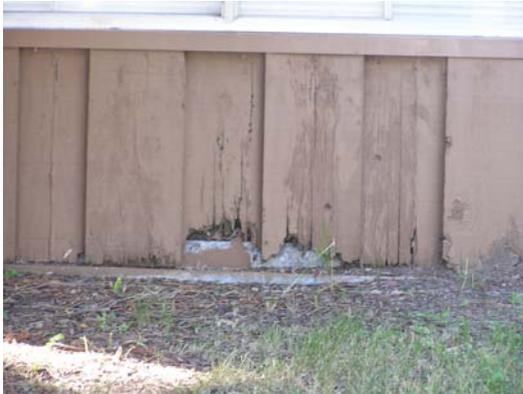
2462 High Ridge Trail
Wood Panel Rotted
July 10, 2005

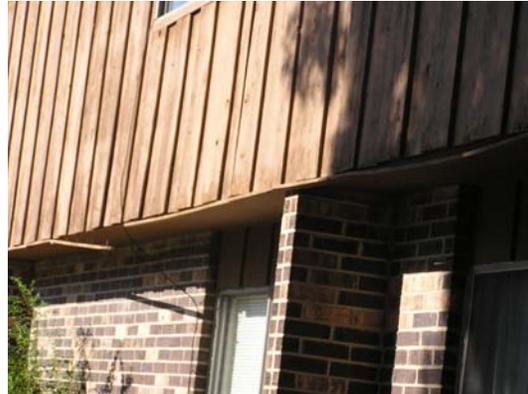
2532 High Ridge Trail
Trim Loose
Trim Sagging
Boards Deteriorated
July 10, 2005
