REZONING APPLICATION

1. **Location of Property/Street Address:** 2556 South Fish Hatchery Road

Independent senior apartments.
 See attached narrative for the request explanation.

Oak Ridge Senior Apartments
 Aerial -Site Plan
 2556 S. Fish Hatchery Rd
 May 20, 2019

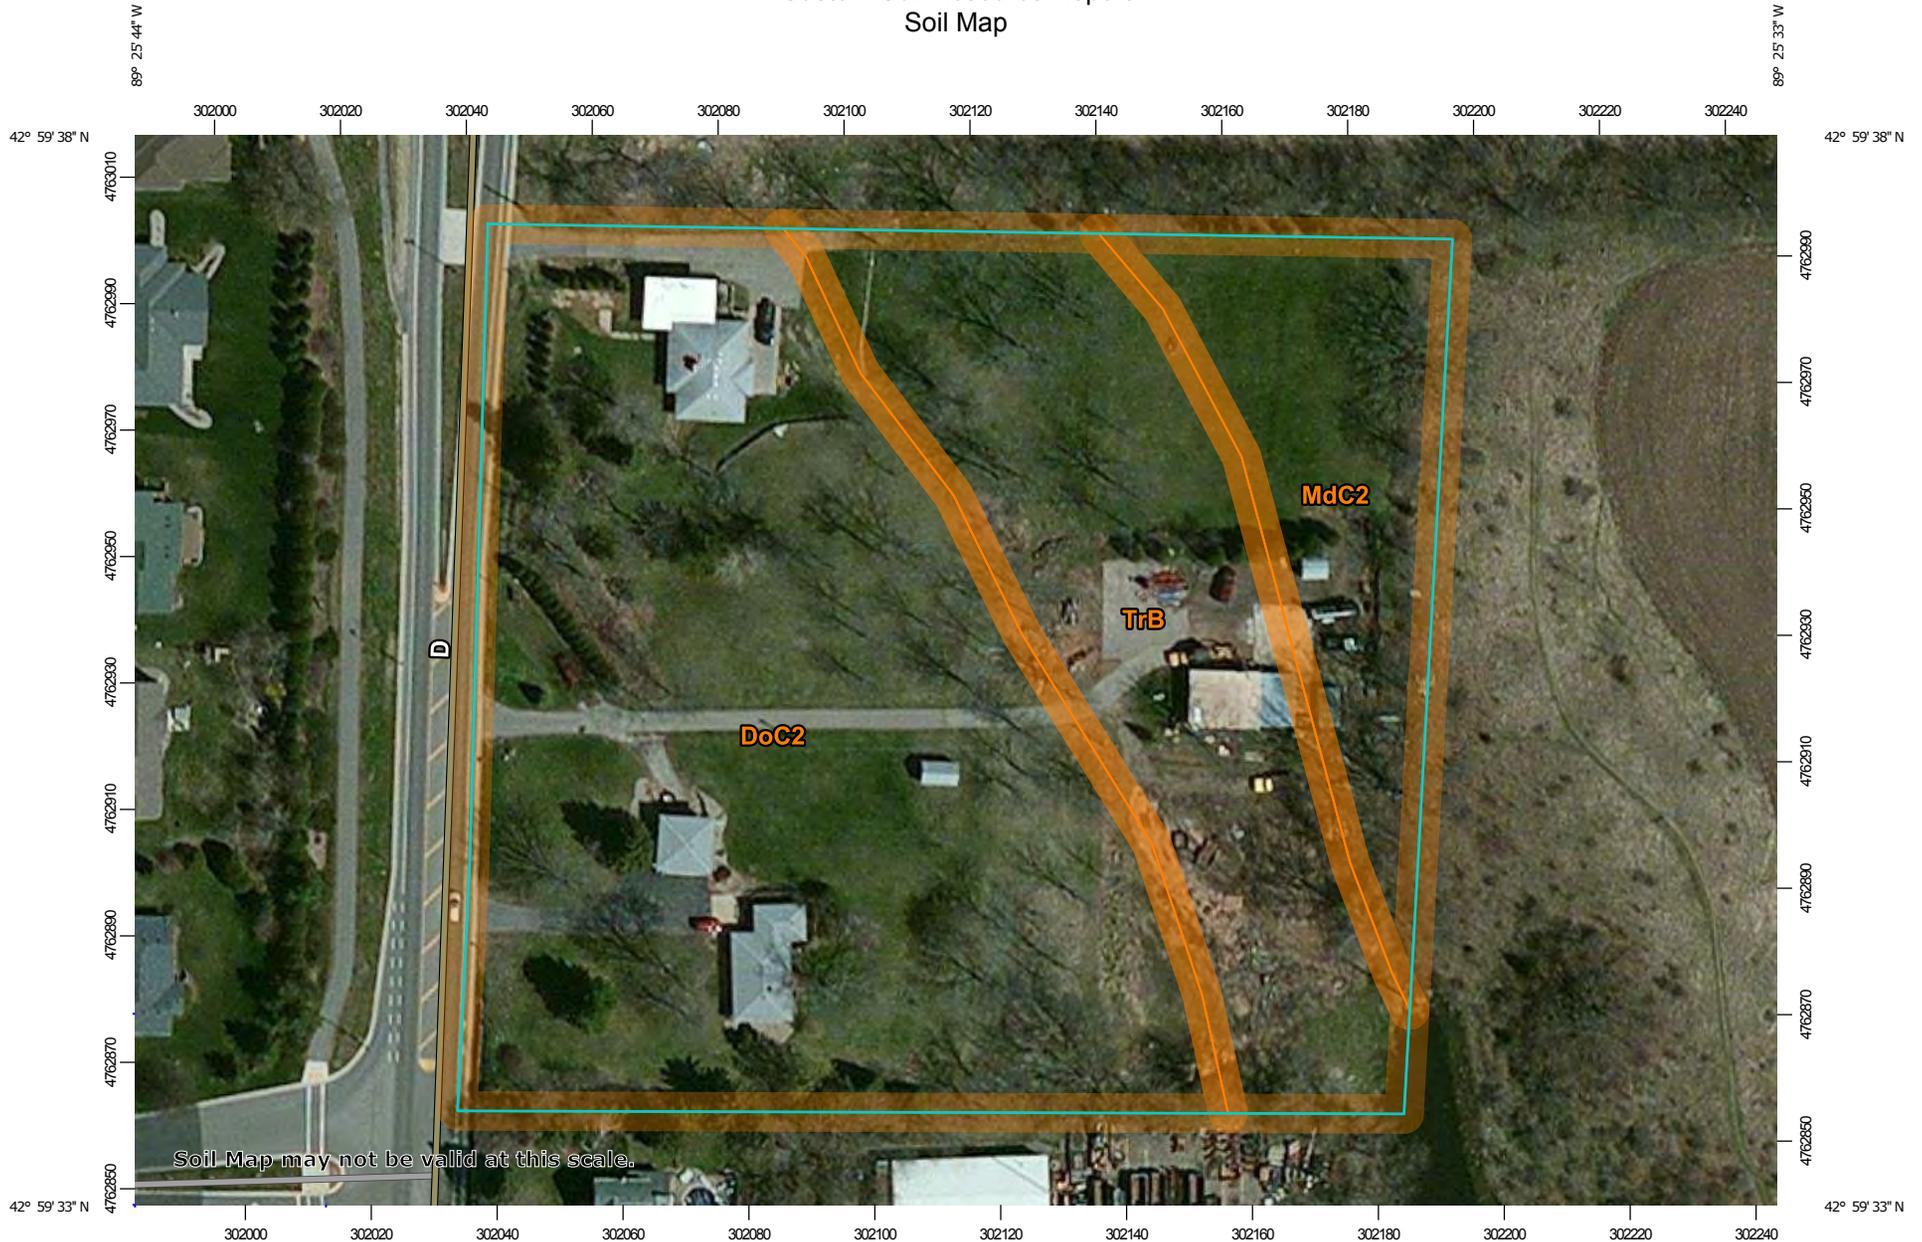
Custom Soil Resource Report Soil Map

The soil map section includes the soil map for the defined area of interest, a list of soil map units on the map and extent of each map unit, and cartographic symbols displayed on the map. Also presented are various metadata about data used to produce the map, and a description of each soil map unit.

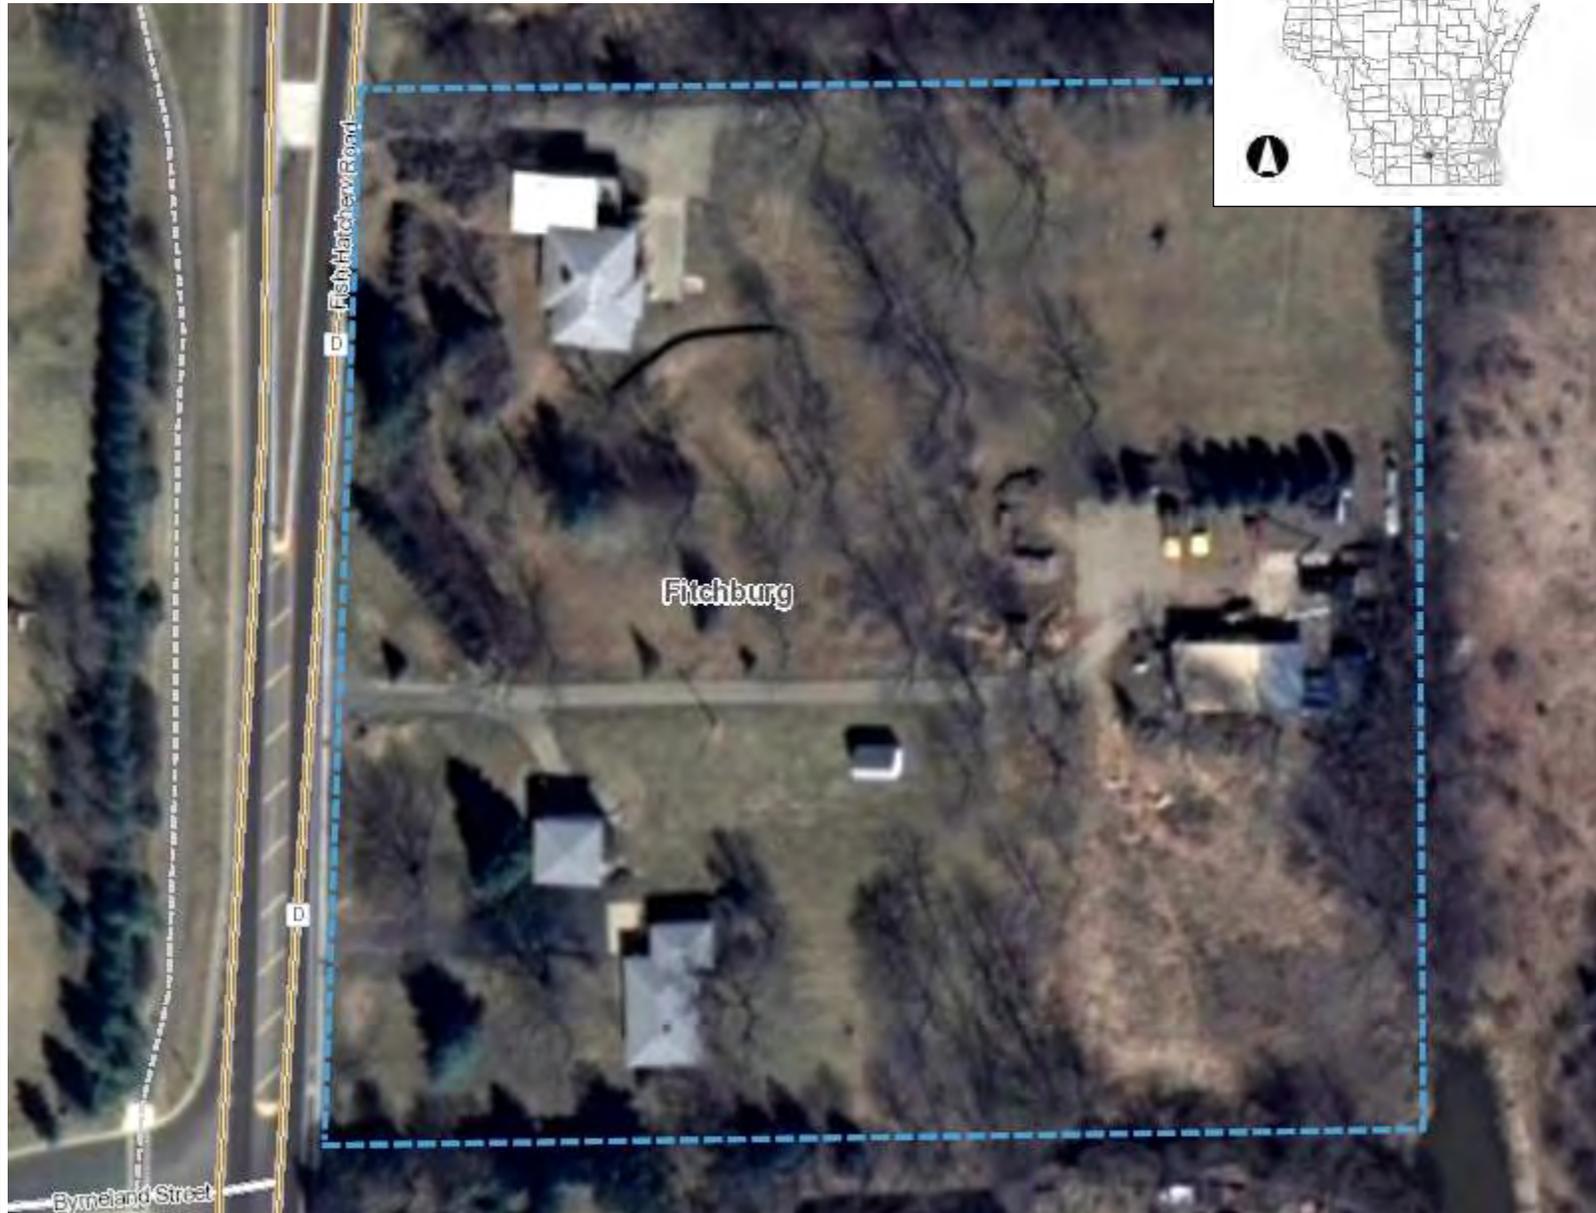
Figure 4: Wisconsin Wetland Inventory - Koth Property

The *Surface Water Data Viewer* (WDNR) web application Wisconsin Wetland Inventory (WWI) data layer (Figure 4, Appendix A) depicts no wetlands within the Study Area. An artificially excavated pond lies outside the southeastern boundary of the Study Area.

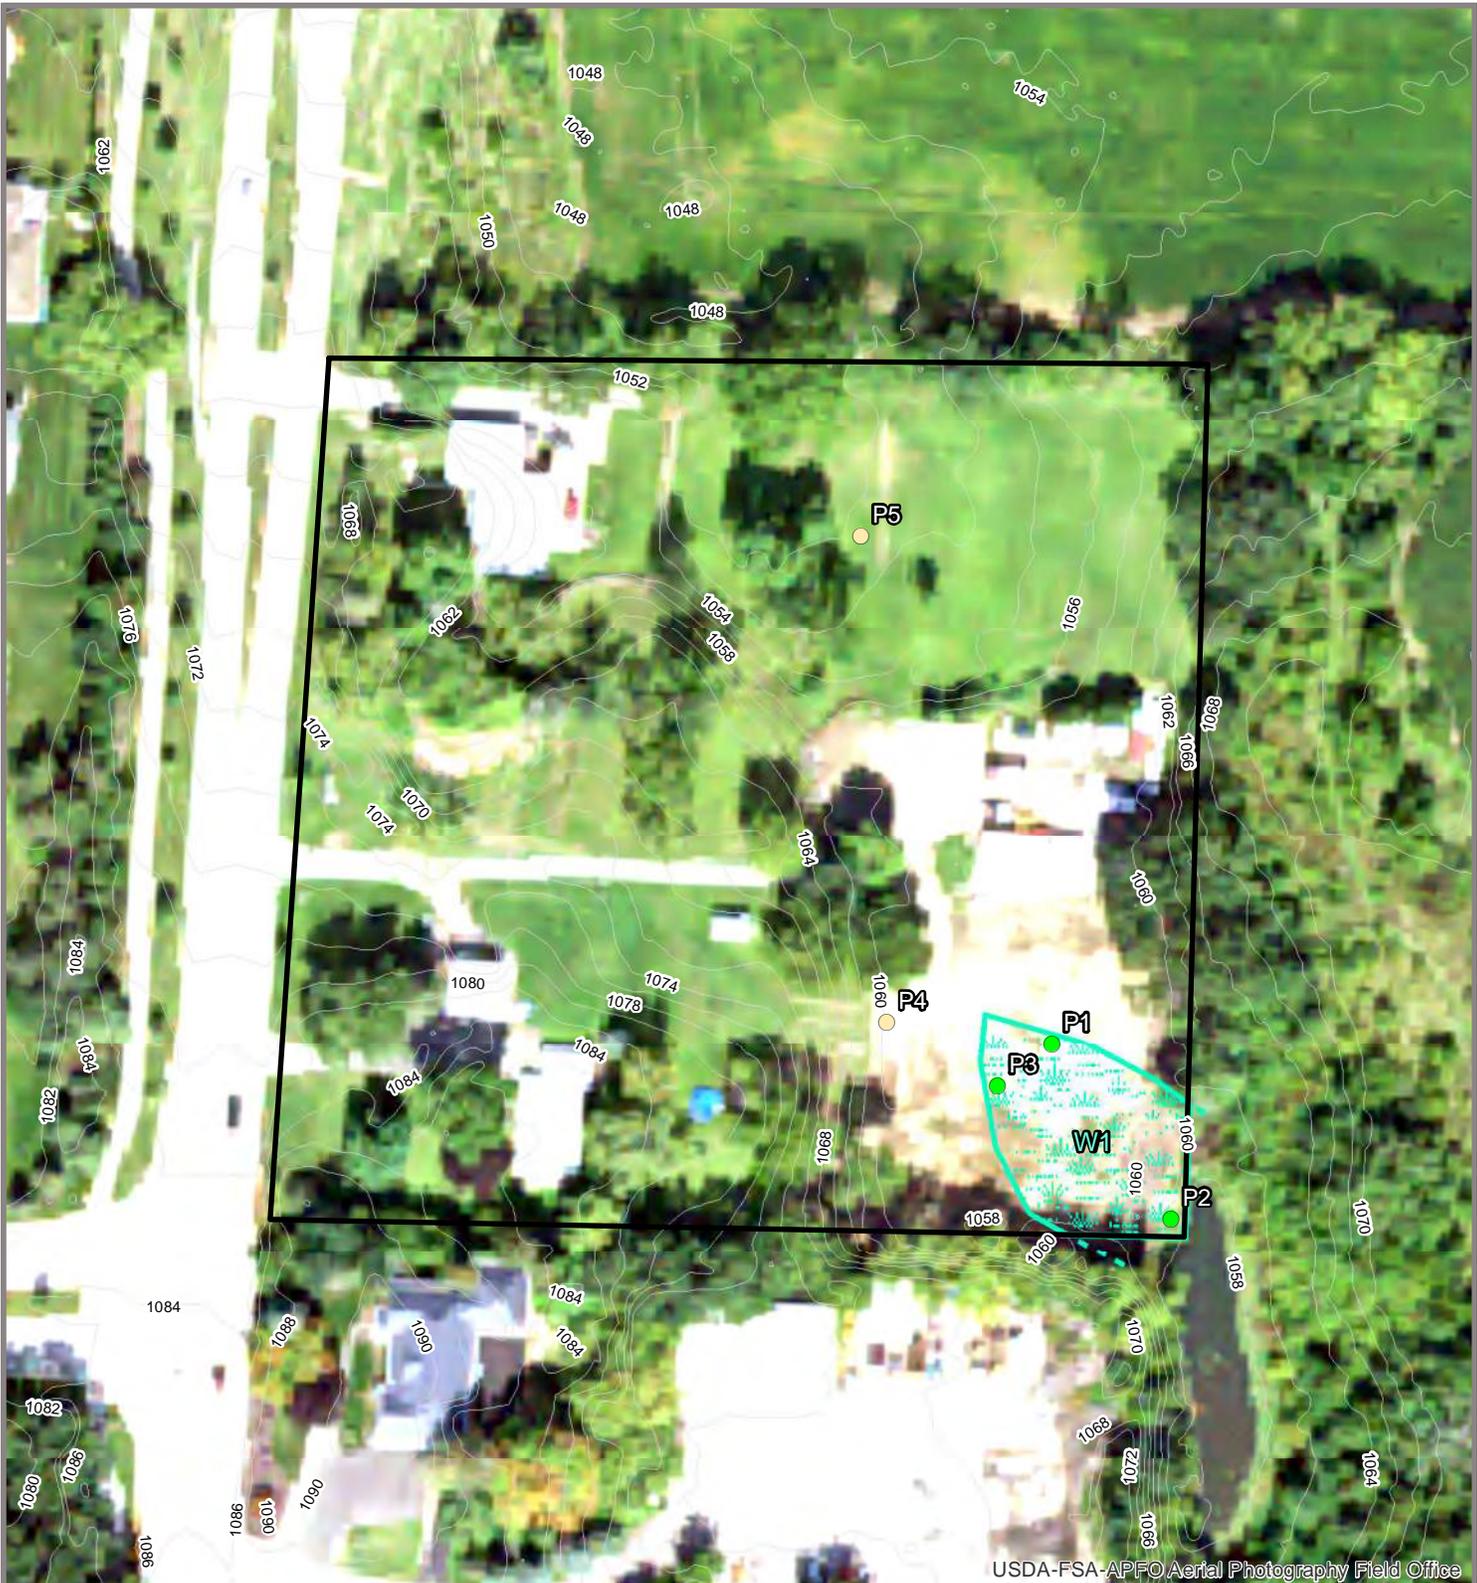
Figure 5. Field Delineated Wetland
Koth Property
#20180010
T6N, R9E, S16
C of Fitchburg, Dane Co, WI
2017 NAIP
Data: Dane Co 5/1/2018

One (1) wetland was identified and delineated within the Study Area which also extends off-site to the south and east, surrounding an off-site pond. Wetland determination data sheets (Appendix D) were completed at five (5) sample points that were representative of the wetland and upland conditions near the boundary and where potential wetlands may be present based on the Desktop Review. Appendix D provides photographs, typically at the sample point locations of the wetlands and adjacent uplands. The wetland boundary and sample point locations are shown on Figure 5 (Appendix A) and the wetlands are summarized in Table 2 and detailed in the following sections.

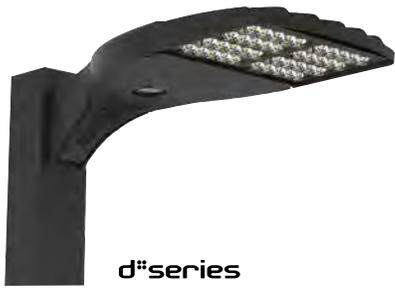
D-Series Size 0 LED Area Luminaire

Included mounting block and integral arm facilitate quick and easy installation. Stainless steel bolts fasten the mounting block securely to poles and walls, enabling the D-Series Size 0 to withstand up to a 3.0 G vibration load rating per ANSI C136.31. The D-Series Size 0 utilizes the AERIS™ series pole drilling pattern (template #8). Optional terminal block and NEMA photocontrol receptacle are also available.

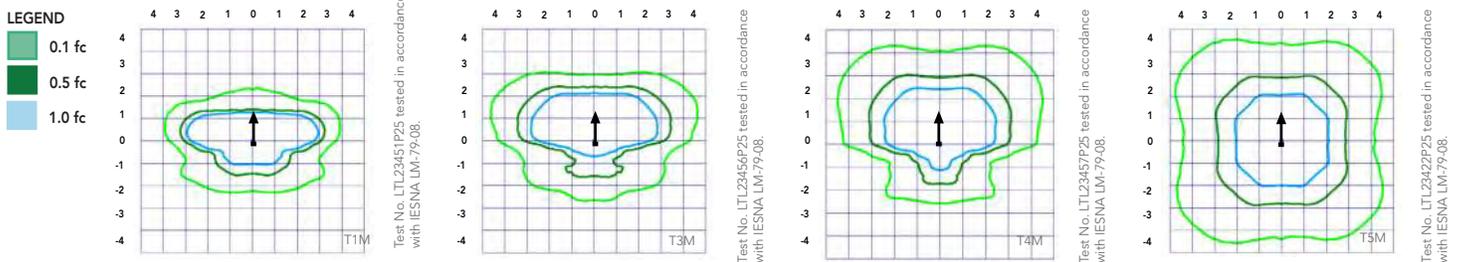
Isofootcandle plots for the DSX0 LED 40C 1000 40K. Distances are in units of mounting height (20').

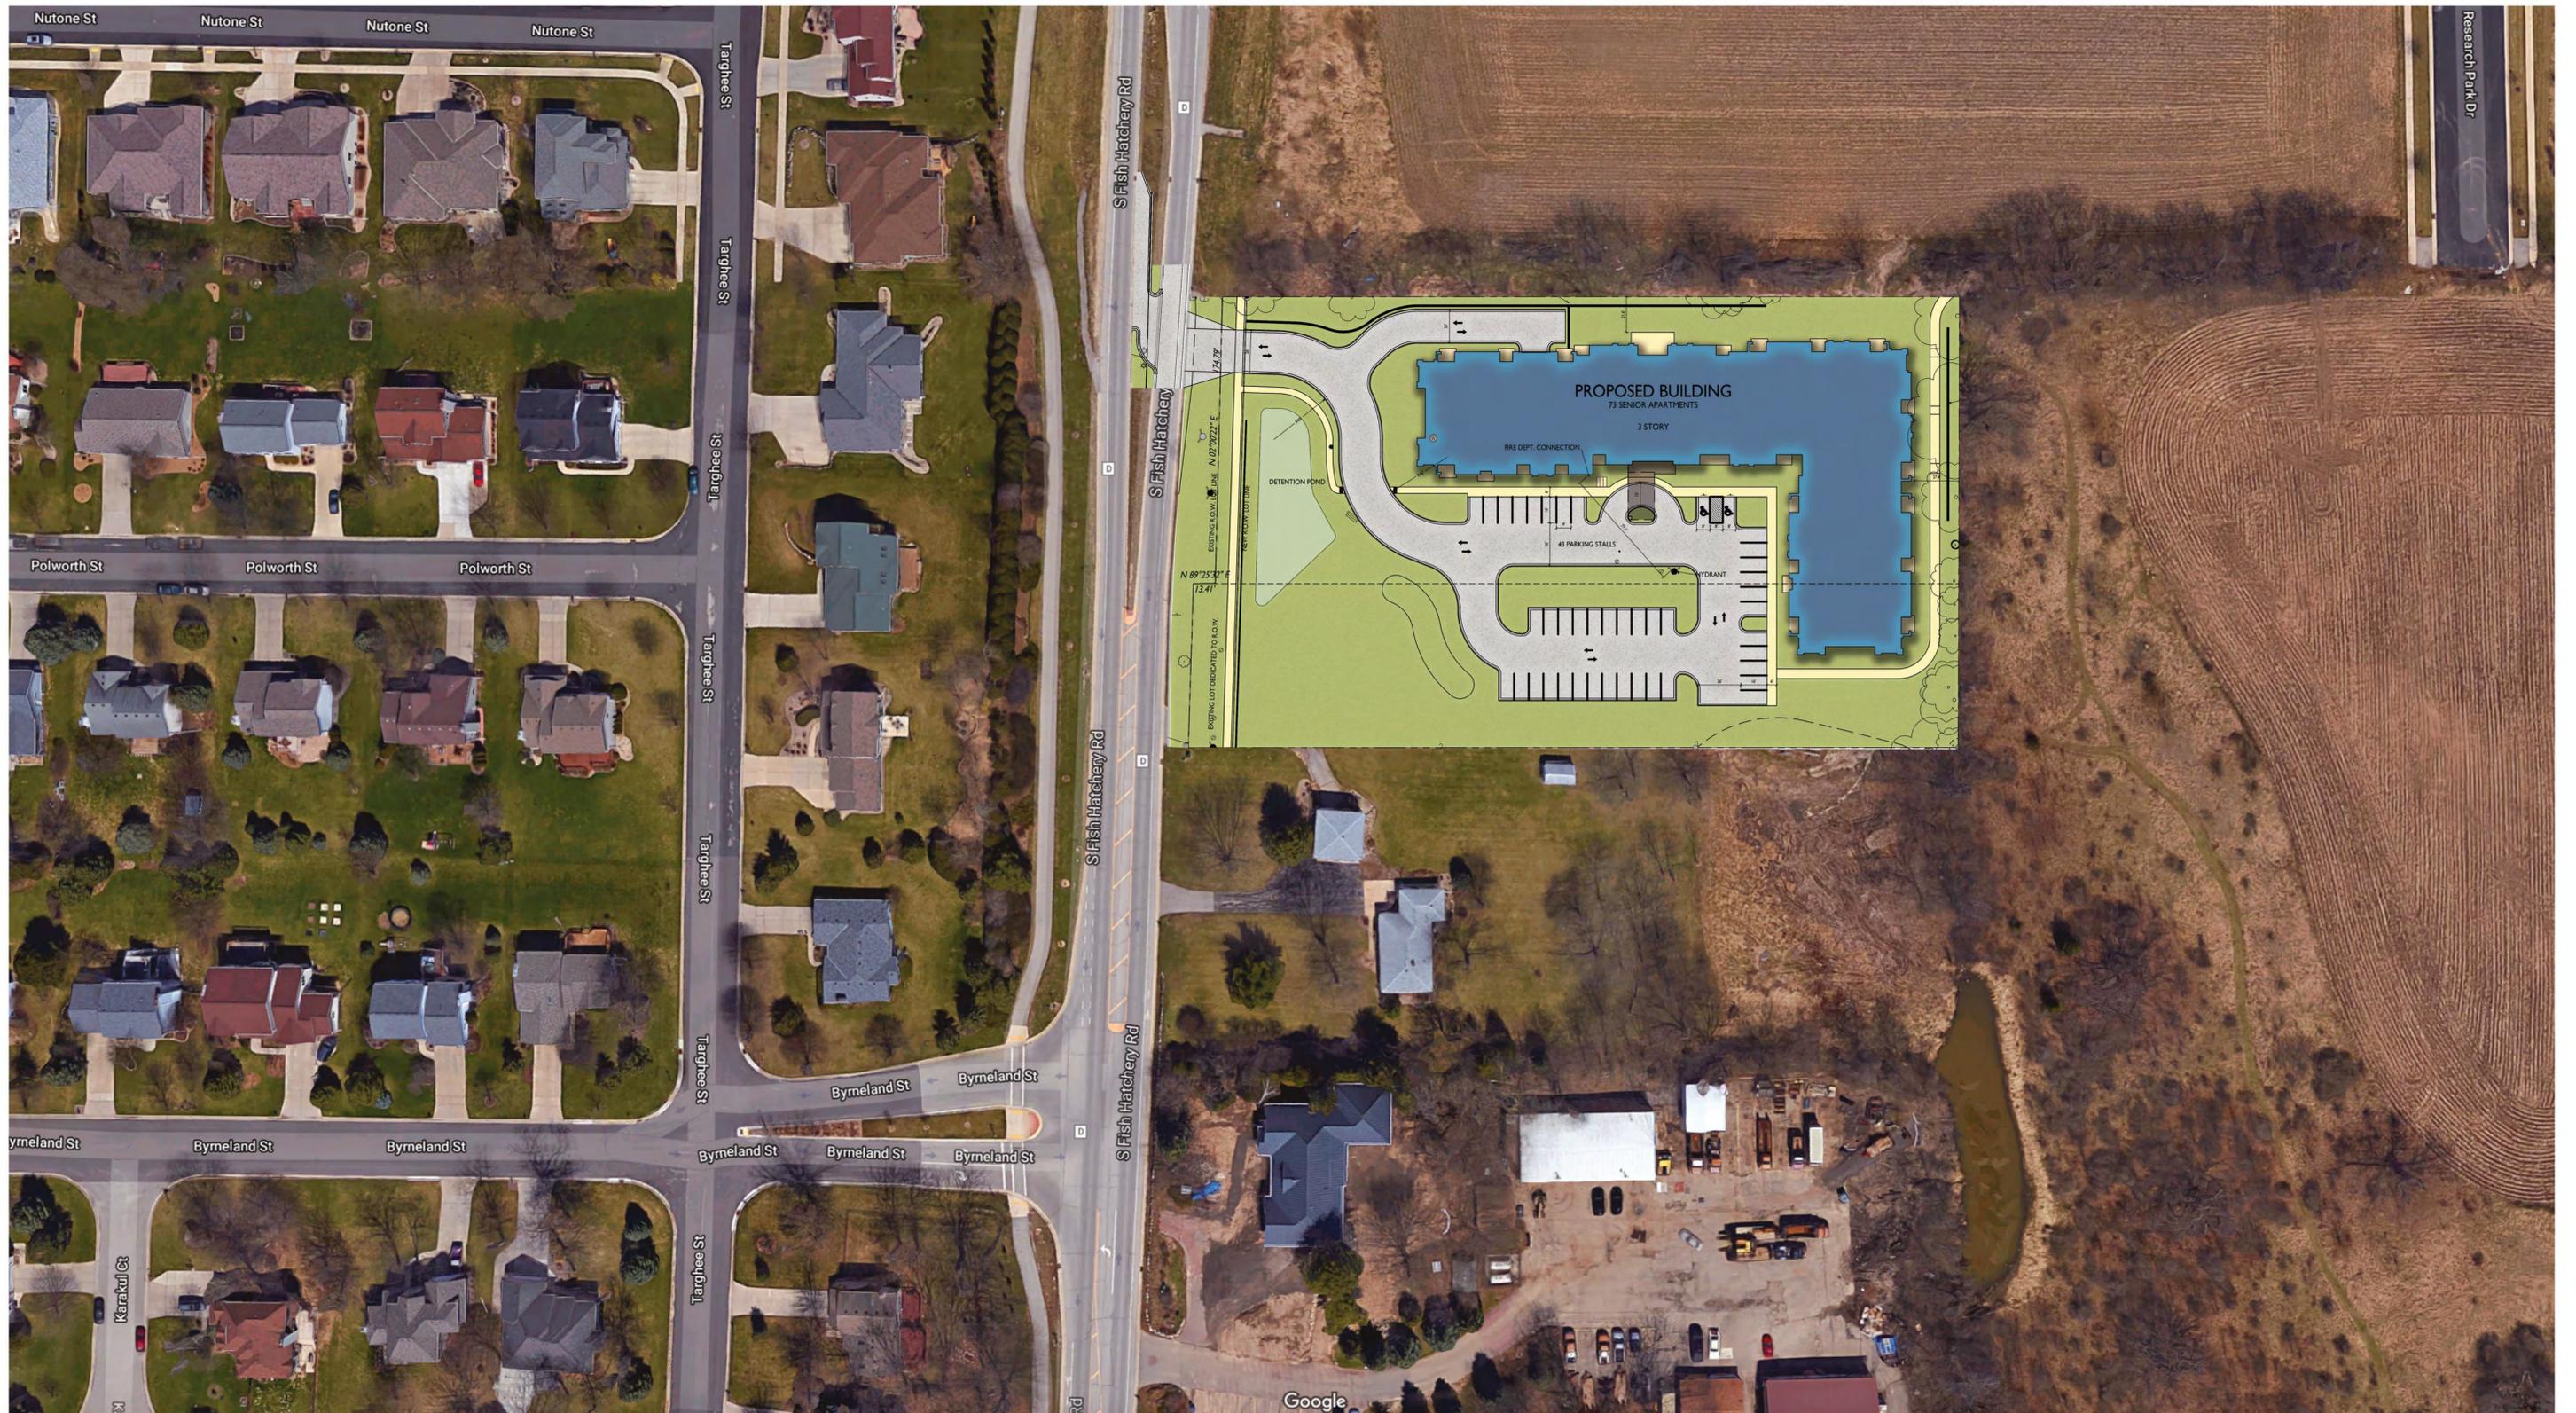
Ample parking will be available onsite. The 73 unit building has a total of 116 stalls including 73 underground and 43 surface parking spaces. This creates a ratio of 1.58 stalls per unit, which is substantially higher than our estimated need for senior housing.

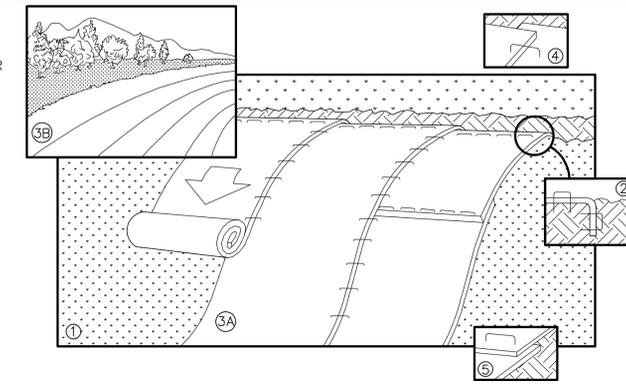
2 EROSION MAT
 NOT TO SCALE
 C-6.1

NOTE: REFER TO GENERAL STAPLE PATTERN GUIDE FOR CORRECT STAPLE PATTERN RECOMMENDATIONS FOR SLOPE INSTALLATIONS.

- PREPARE SOIL BEFORE INSTALLING BLANKETS, INCLUDING APPLICATION OF FERTILIZER AND SEED.
 NOTE: WHEN USING CELL-O-SEED, DO NOT SEED PREPARED AREA. CELL-O-SEED MUST BE INSTALLED WITH PAPER SIDE DOWN.
- BEGIN AT THE TOP OF THE SLOPE BY ANCHORING THE BLANKET IN 6" DEEP BY 6" WIDE TRENCH. BACKFILL AND COMPACT THE TRENCH AFTER STAPLING.
- ROLL THE BLANKETS <A.> DOWN, OR <B.> HORIZONTALLY ACROSS THE SLOPE.
- THE EDGES OF PARALLEL BLANKETS MUST BE STAPLED WITH APPROXIMATELY 2" OVERLAP.
- WHEN BLANKETS MUST BE SPLICED DOWN THE SLOPE, PLACE BLANKETS END OVER END (SHINGLE STYLE) WITH APPROXIMATELY 4" OVERLAP. STAPLE THROUGH OVERLAPPED AREA, APPROXIMATELY 12" APART.
- ALL BLANKETS MUST BE SECURELY FASTENED TO THE SLOPE BY PLACING STAPLES/STAKES IN APPROPRIATE LOCATIONS AS RECOMMENDED BY THE MANUFACTURER.

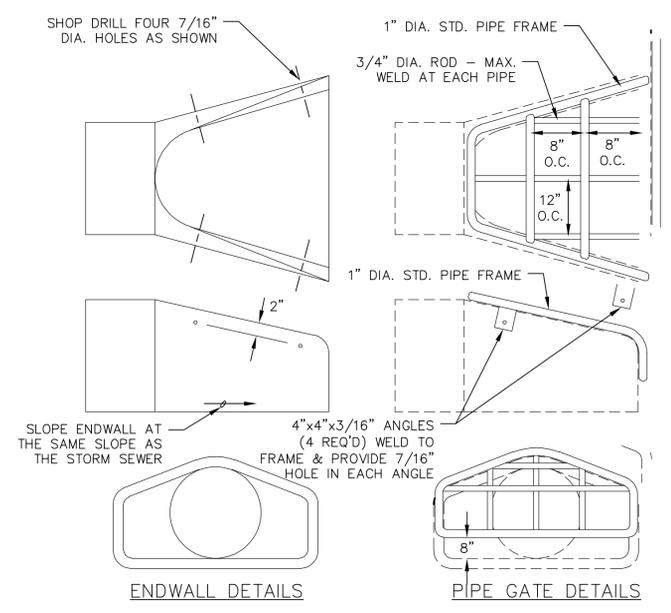
4 STANDARD ENDWALL
C-6.3 NOT TO SCALE

NOTES:
 - THE CONTRACTOR SHALL BOLT THE PIPE GATE TO THE CONCRETE ENDWALL WITH FOUR 3/8"x6" MACHINE BOLTS WITH NUTS ON INSIDE WALL.
 - THE CONTRACTOR SHALL PROVIDE JOINT TIES ON STORM SEWER SYSTEM INFALL AND OUTFALL PIPES. TIE THE ENDWALL AND THE LAST 2 PIPE SECTIONS.

PAINTING SPECIFICATIONS:
 - THE PIPE GATE SHALL RECEIVE THE FOLLOWING PREPARATION & PAINTING. THE FIRST COAT SHALL BE RUS-OLEUM X-60 RED BARE METAL PRIMER OR APPROVED EQUAL. THE SECOND COAT SHALL BE RUS-OLEUM 960 ZINC CHROMATE PRIMER OR APPROVED EQUAL. THE THIRD COAT SHALL BE RUS-OLEUM 1282 HIGH GLOSS METAL FINISH OR APPROVED EQUAL.

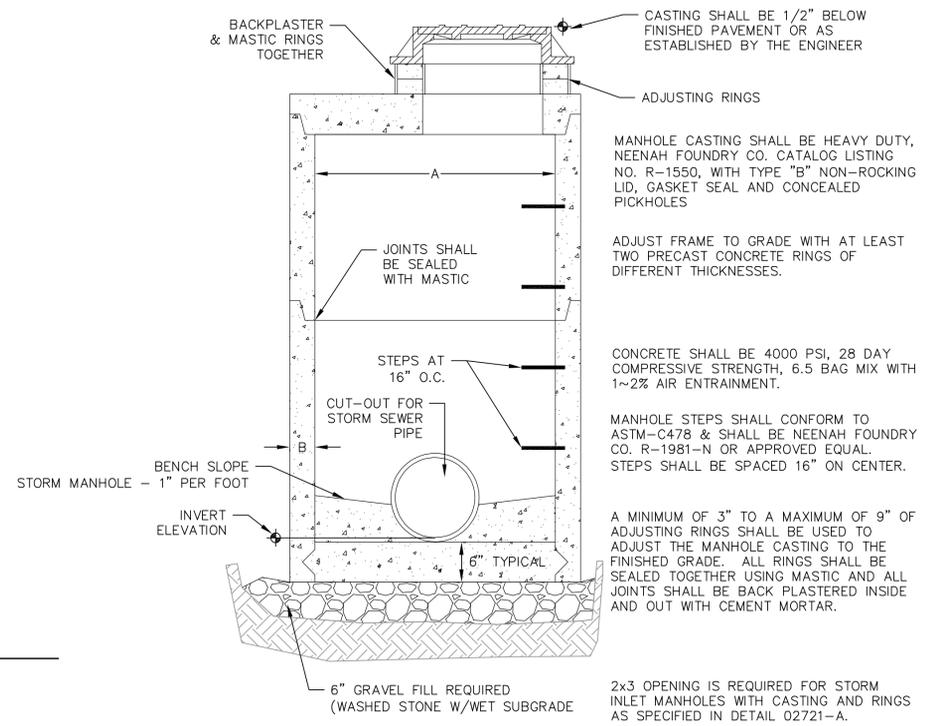
5 STORM SEWER MANHOLE
C-6.3 NOT TO SCALE

MANHOLE SIZE	DIMENSION	
	A	B (MIN.)
48"	48"	5"
60"	60"	6"
72"	72"	7"
84"	84"	7"
96"	96"	9"

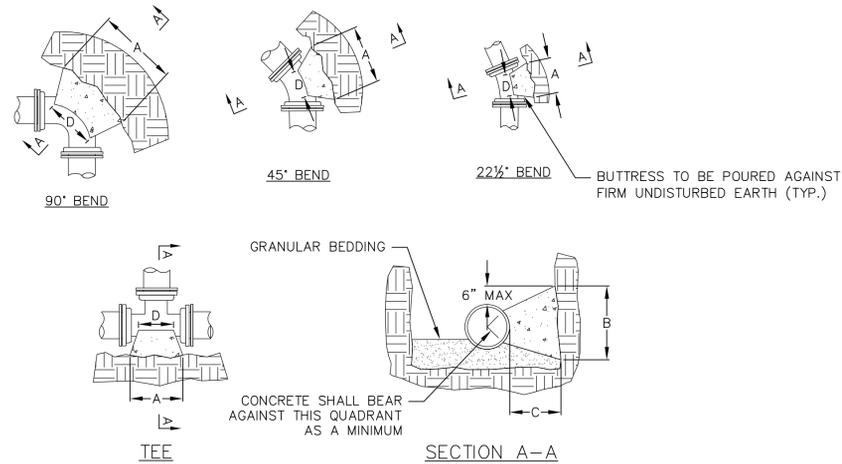
2 BUTTRESS FOR BENDS
C-6.3 NOT TO SCALE

DIMENSION "D" SHALL BE AS LARGE AS POSSIBLE, BUT THE CONCRETE SHALL NOT INTERFERE WITH THE MECHANICAL JOINTS.

DIMENSION "C" SHALL BE AT LEAST 6 INCHES, AND LARGE ENOUGH TO MAKE THE "Q" ANGLE EQUAL TO OR GREATER THAN 45 DEGREES WITH THE DIMENSION "A" AS SHOWN ON THE TABLE, OR GREATER, AND WITH DIMENSION "D" AS LARGE AS POSSIBLE.

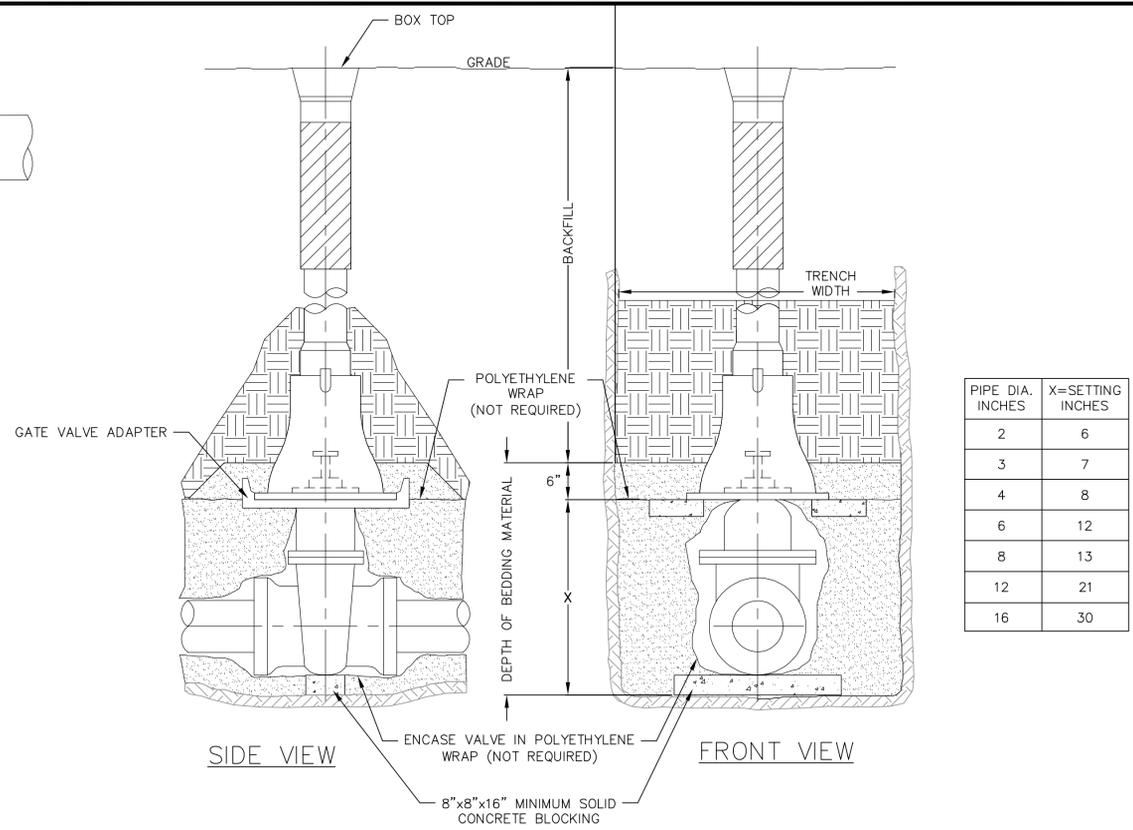
3 STANDARD GATE VALVE BOX SETTING
C-6.3 NOT TO SCALE

PIPE DIA. INCHES	X=SETTING INCHES
2	6
3	7
4	8
6	12
8	13
12	21
16	30

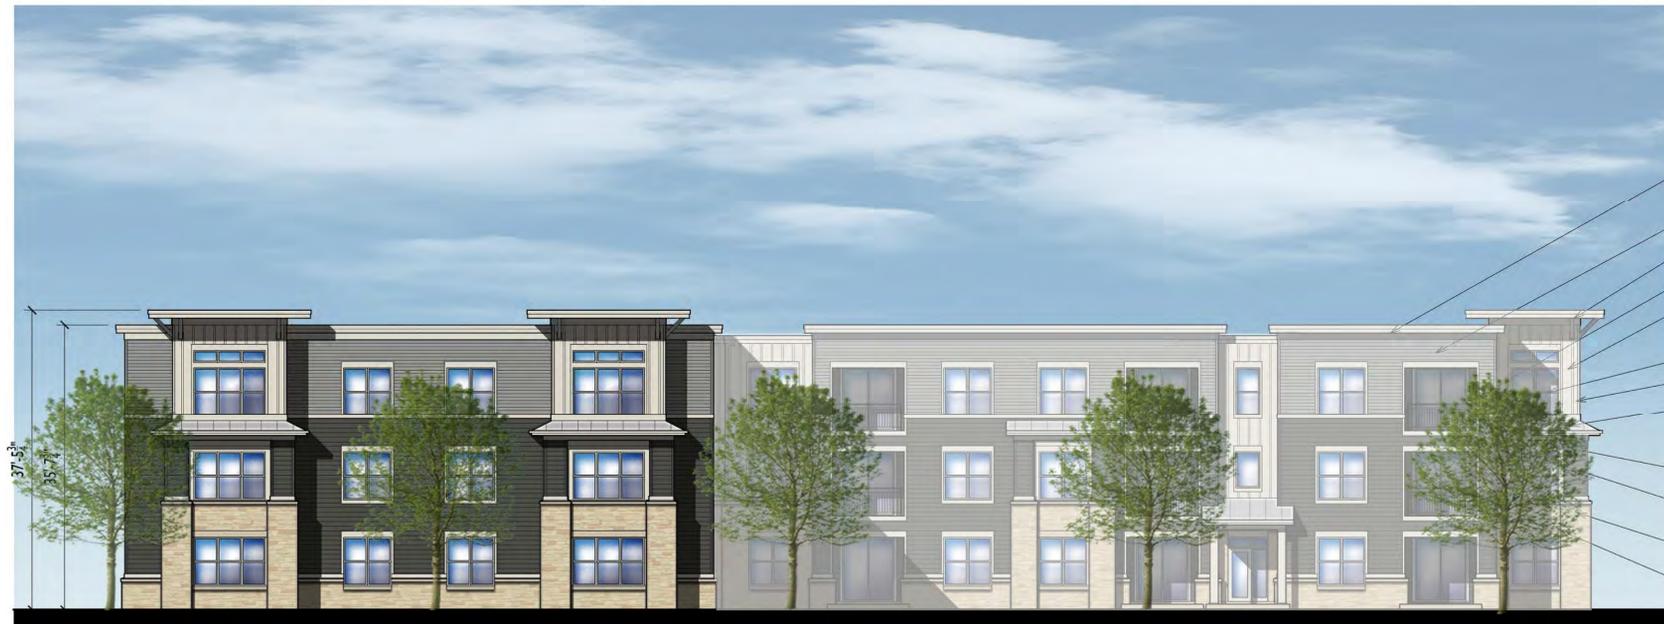
West Elevation along Fish Hatchery Rd.

- SOFFITS & FASCIA
- COMPOSITE SIDING - A
- COMPOSITE BRACKETS
- COMPOSITE SIDING - B
- COMPOSITE BOARD AND BATTEN SIDING
- VINYL WINDOWS
- COMPOSITE SIDING - B
- STANDING SEAM METAL ROOFING
- ALUM. RAILING
- COMPOSITE WINDOW AND DOOR TRIM
- STONE VENEER
- PRECAST HEADS & SILLS

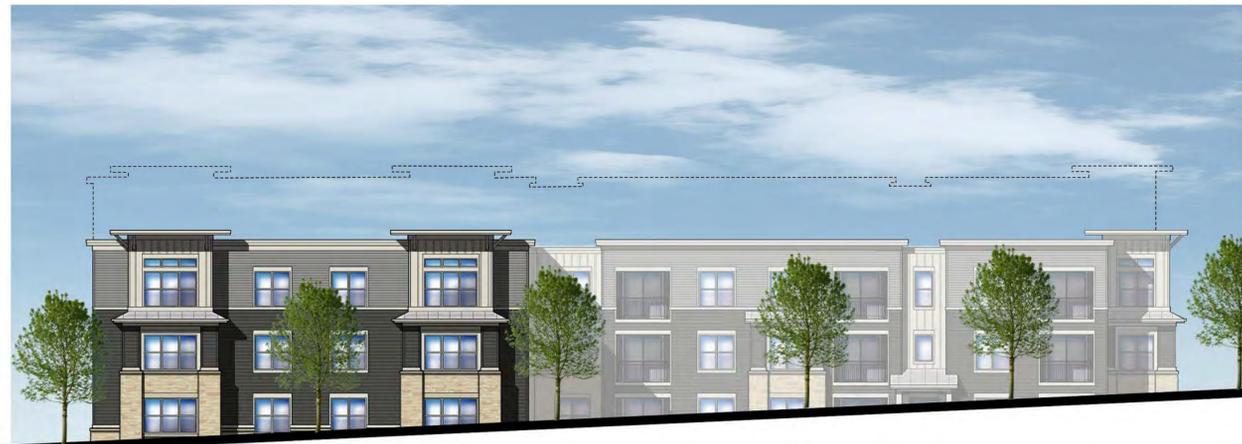
SITE SECTION

Oak Ridge Senior Apartments
Site Section
S. Fish Hatchery
May 20, 2019
